FAIRPLAY RIVER PARK

ECOLOGICAL ASSESSMENT

PARK COUNTY, COLORADO
SEPTEMBER, 2018

DHM DESIGN

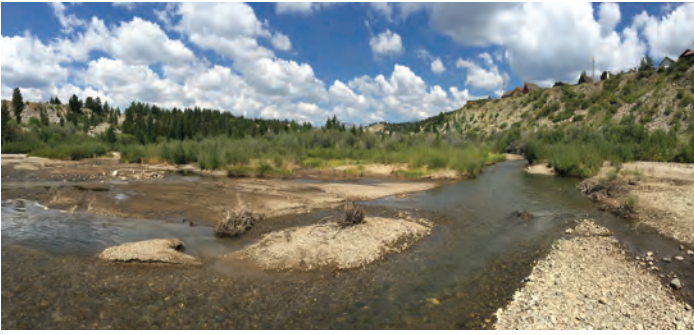
The upper reach within the Project Area consists a meandering primary river channel with active secondary channels and branches. Braiding occurs as the stream reaches the Pond. The entrenchment ratio throughout this section varies from slightly entrenchment to little or no entrenchment. Mid-channel bars formed from rapid deposition occur throughout the reach and point bars and braided channels disperse flow across the floodplain in this area (See figure 7). The dominant bed form in this section is pool riffle and step pool. Fishing opportunities occur throughout this section, constraints to fish habitat include cover and river depth. There are many naturally occurring riffles that provide good macroinvertebrate habitat as well as step pools and cutbanks in this section that provide good cover and habitat for fish (See figure 8). Beaver activity within this reach has created several backwater areas that provide excellent juvenile fish rearing habitat (See figure 9). Spawning habitat occurs throughout the reach in pool tailouts and side channels. Overall, minimal bank erosion is occurring throughout this section of reach, there is one area with significant bank erosion located in the

FIGURE 7- View looking at braided section of river, braided channels and dispersed flow.

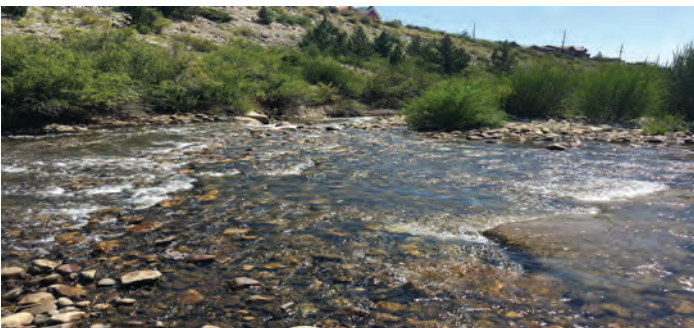
FIGURE 8- View looking at step pool and riffle section of river.

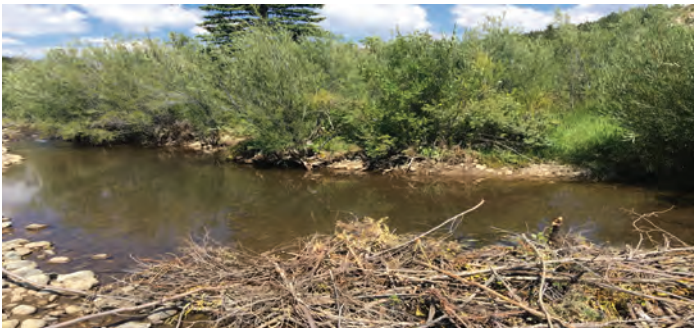
FIGURE 9- View looking at fish rearing backwater habitat created by beaver dam.

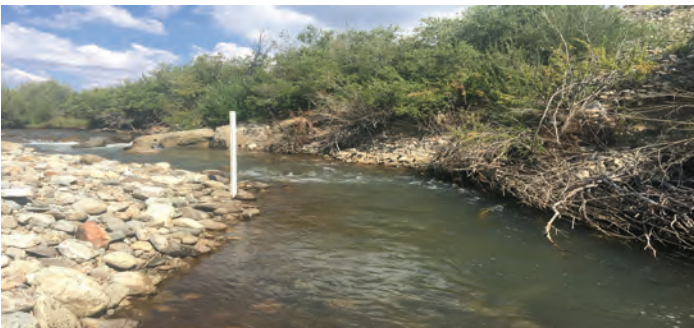
FIGURE 10 - View looking at significant bank erosion in Upper Reach.

middle of the reach downstream of a fish habitat structure (See figure 10). Multiple active channels within this section constrain low flow and function of river improvement features.

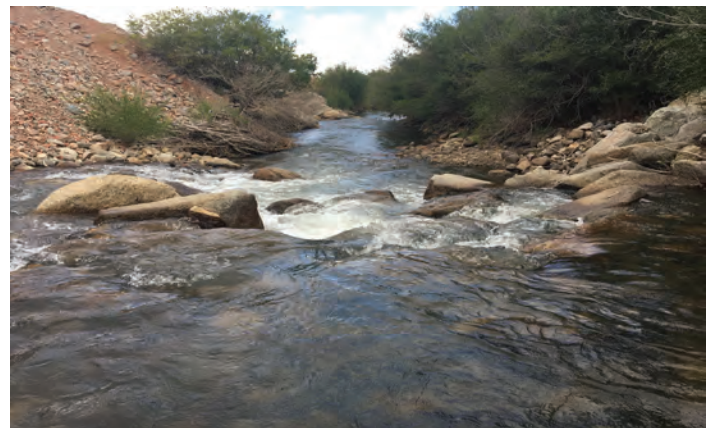
FIGURE 11- View looking at entrenched area where side bank erosion is taking place undermining existing river structure.

tailings (See figure 11). Deposition from active erosion in these areas have decreased river depth and degraded fish habitat. The existing fish habitat structures throughout the reach are mostly functioning and provide good holding water and cover for fish. Some structures are being undermined by active erosion where mine tailings exist and areas where active gold panning is taking place (See figures 12 and 13 previous page). Fishing opportunities are limited in this section and access is challenging do to unstable steep banks.

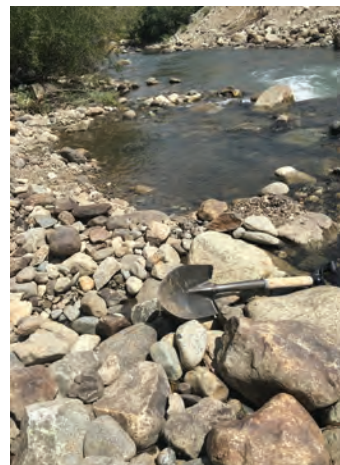
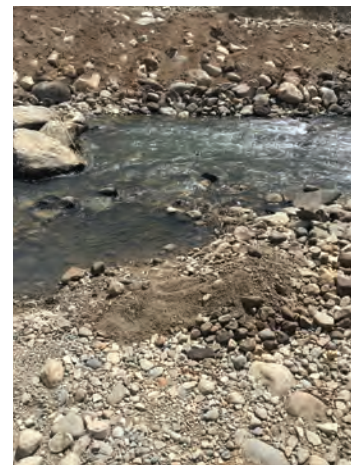
FIGURES 12 & 13- View looking at active gold panning areas where bank erosion and degradation are taking place.

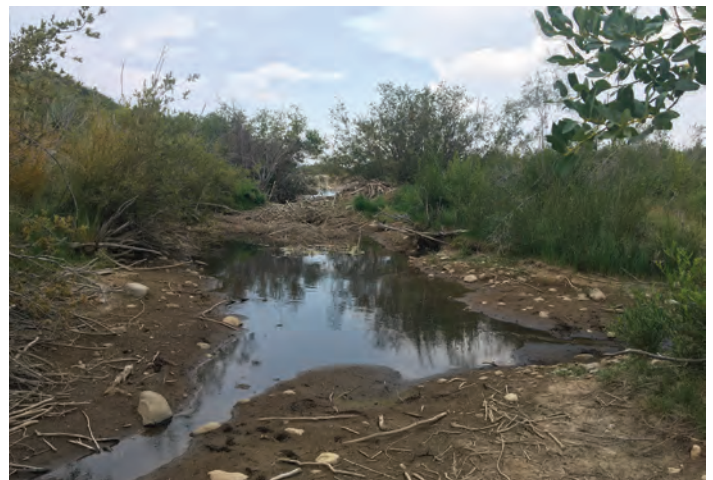
FIGURE 15 - View looking at recommended area for riparian and wetland enhancement opportunity.

Riparian enhancement will improve existing conditions to increase habitat value. This is done through the development and implementation of a weed management plan to control noxious vegetation, identifying aboricultural maintenance needs/plans and increasing plant diversity through planting and seeding. The resulting enhancement will provide increased habitat value for wildlife and improve overall ecological conditions. This report recommends that Project Area Stakeholders consider interventions to enhance approximately

1.7 acres of riparian habitat (see figure 15).

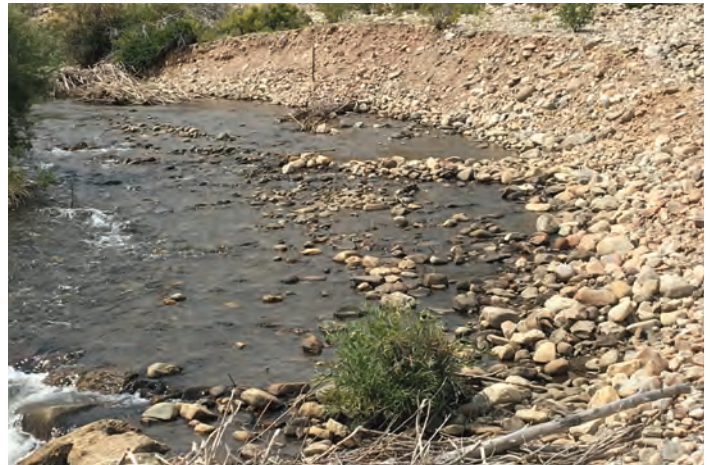
FIGURE 16 - View looking at location for riparian creation. Minor grading and plantings stabilize bank.

Riparian creation is the most intensive of the three types of restoration. This involves grading the topography to create elevations with the appropriate available water to support native riparian vegetation plantings. Areas identified within the report are immediately adjacent to the river bank and are located in close proximity to the river water table. Areas identified for bank stabilization as part of river improvements are ideal locations for this recommended intervention as bank stabilization and riparian creation are both interventions with overlapping goals. This report recommends that at the Project Area Stakeholders consider 1.8 acres of Riparian Creation (see figure 16).

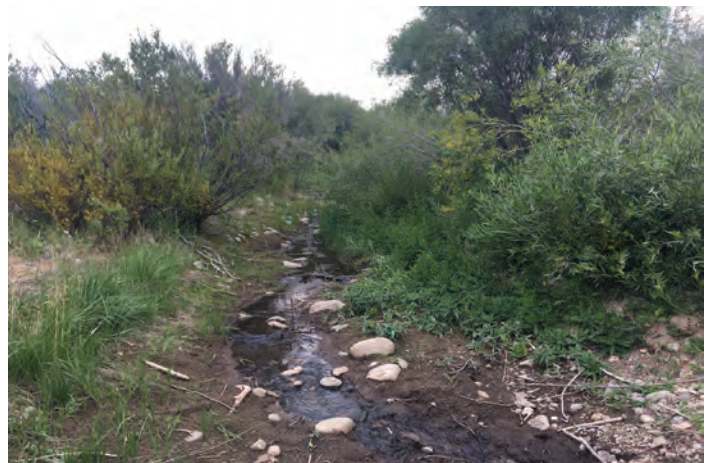
FIGURE 18- View looking at opportunity for Wetland Enhancement. Large thistle patch encroaching on wetland channel.

can enhance what is already considered a high-quality wetland within the Project Area. This report recommends that at the Project Area Stakeholders consider 1.2 acres within the Project Area for wetland enhancement (see figure 18).

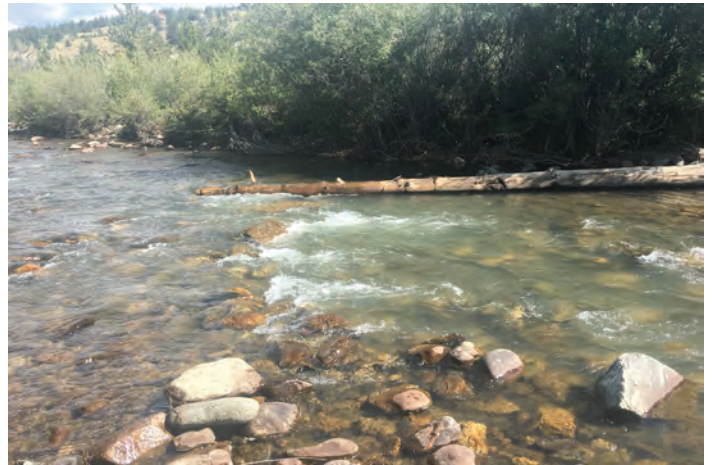
FIGURE 19 - View looking at functioning existing structure and placed log for habitat.

River restoration and maintenance opportunities exist throughout the Project Area. An evaluation of the existing river habitat structures, stream channel and function was conducted and recommendations in this section are based on those observations. Overall, there is a need for minor maintenance to some of the existing instream structures to increase function and prevent further erosion and degradation. The Project Area contains an abundance of root wads, logs and large boulders, these materials could be utilized for areas where bank stabilization is needed and as instream habitat features to improve overall habitat diversity and composition. An example of functioning structures and created habitat can be found on the very upstream section of the Project Area (See figure 19).

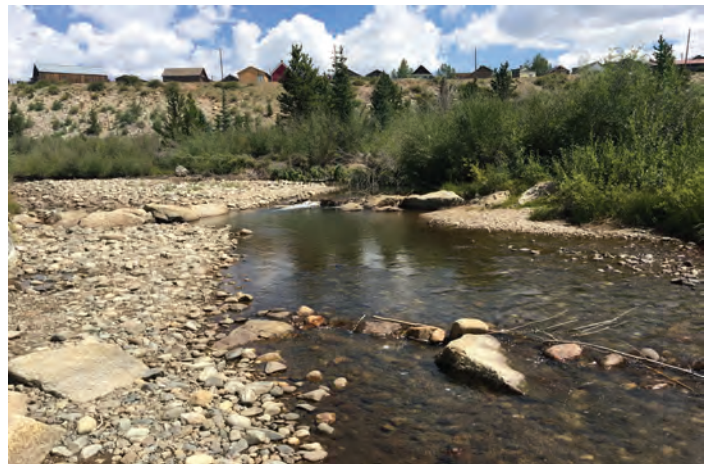
The flood event that occurred in 2015 has caused significant headcutting in areas (particularly upstream of the Pond) in which the migration of cobble and other substrate has created large point bars on both sides of the river and the stream channel has filled in places (See figure 20). Regrading and removal of cobble and substrate in these areas would improve low flow channel conditions, increase pool depths, and improve overall aquatic habitat and river function. There are several areas where the channel is wide and the low flow velocity is minimal, utilizing excavated material from point bars would improve low flow conditions in these areas (See figure 21). The removal or regrading of mine tailings in areas identified on the Stream Improvement Opportunities Graphic in Appendix A would significantly improve the overall function and aquatic habitat. This would allow the river to better connect to the floodplain, stabilize the bank and prevent further erosion and allow for the progression of the river planform from a straight confined section to a more sinuous, meandering

FIGURE 20- View looking at point bars and areas where cobble and other substrate has filled in active channel.

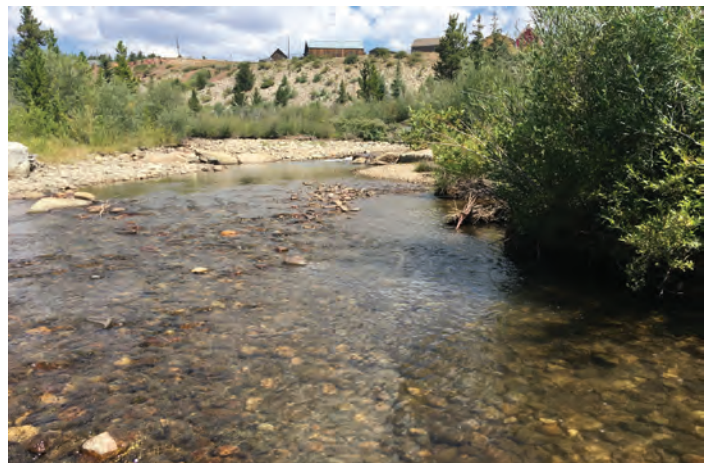
FIGURE 21 - View looking at area requiring maintenance to increase low flow and improve habitat in channel.

form. This would also create better river access in these areas.

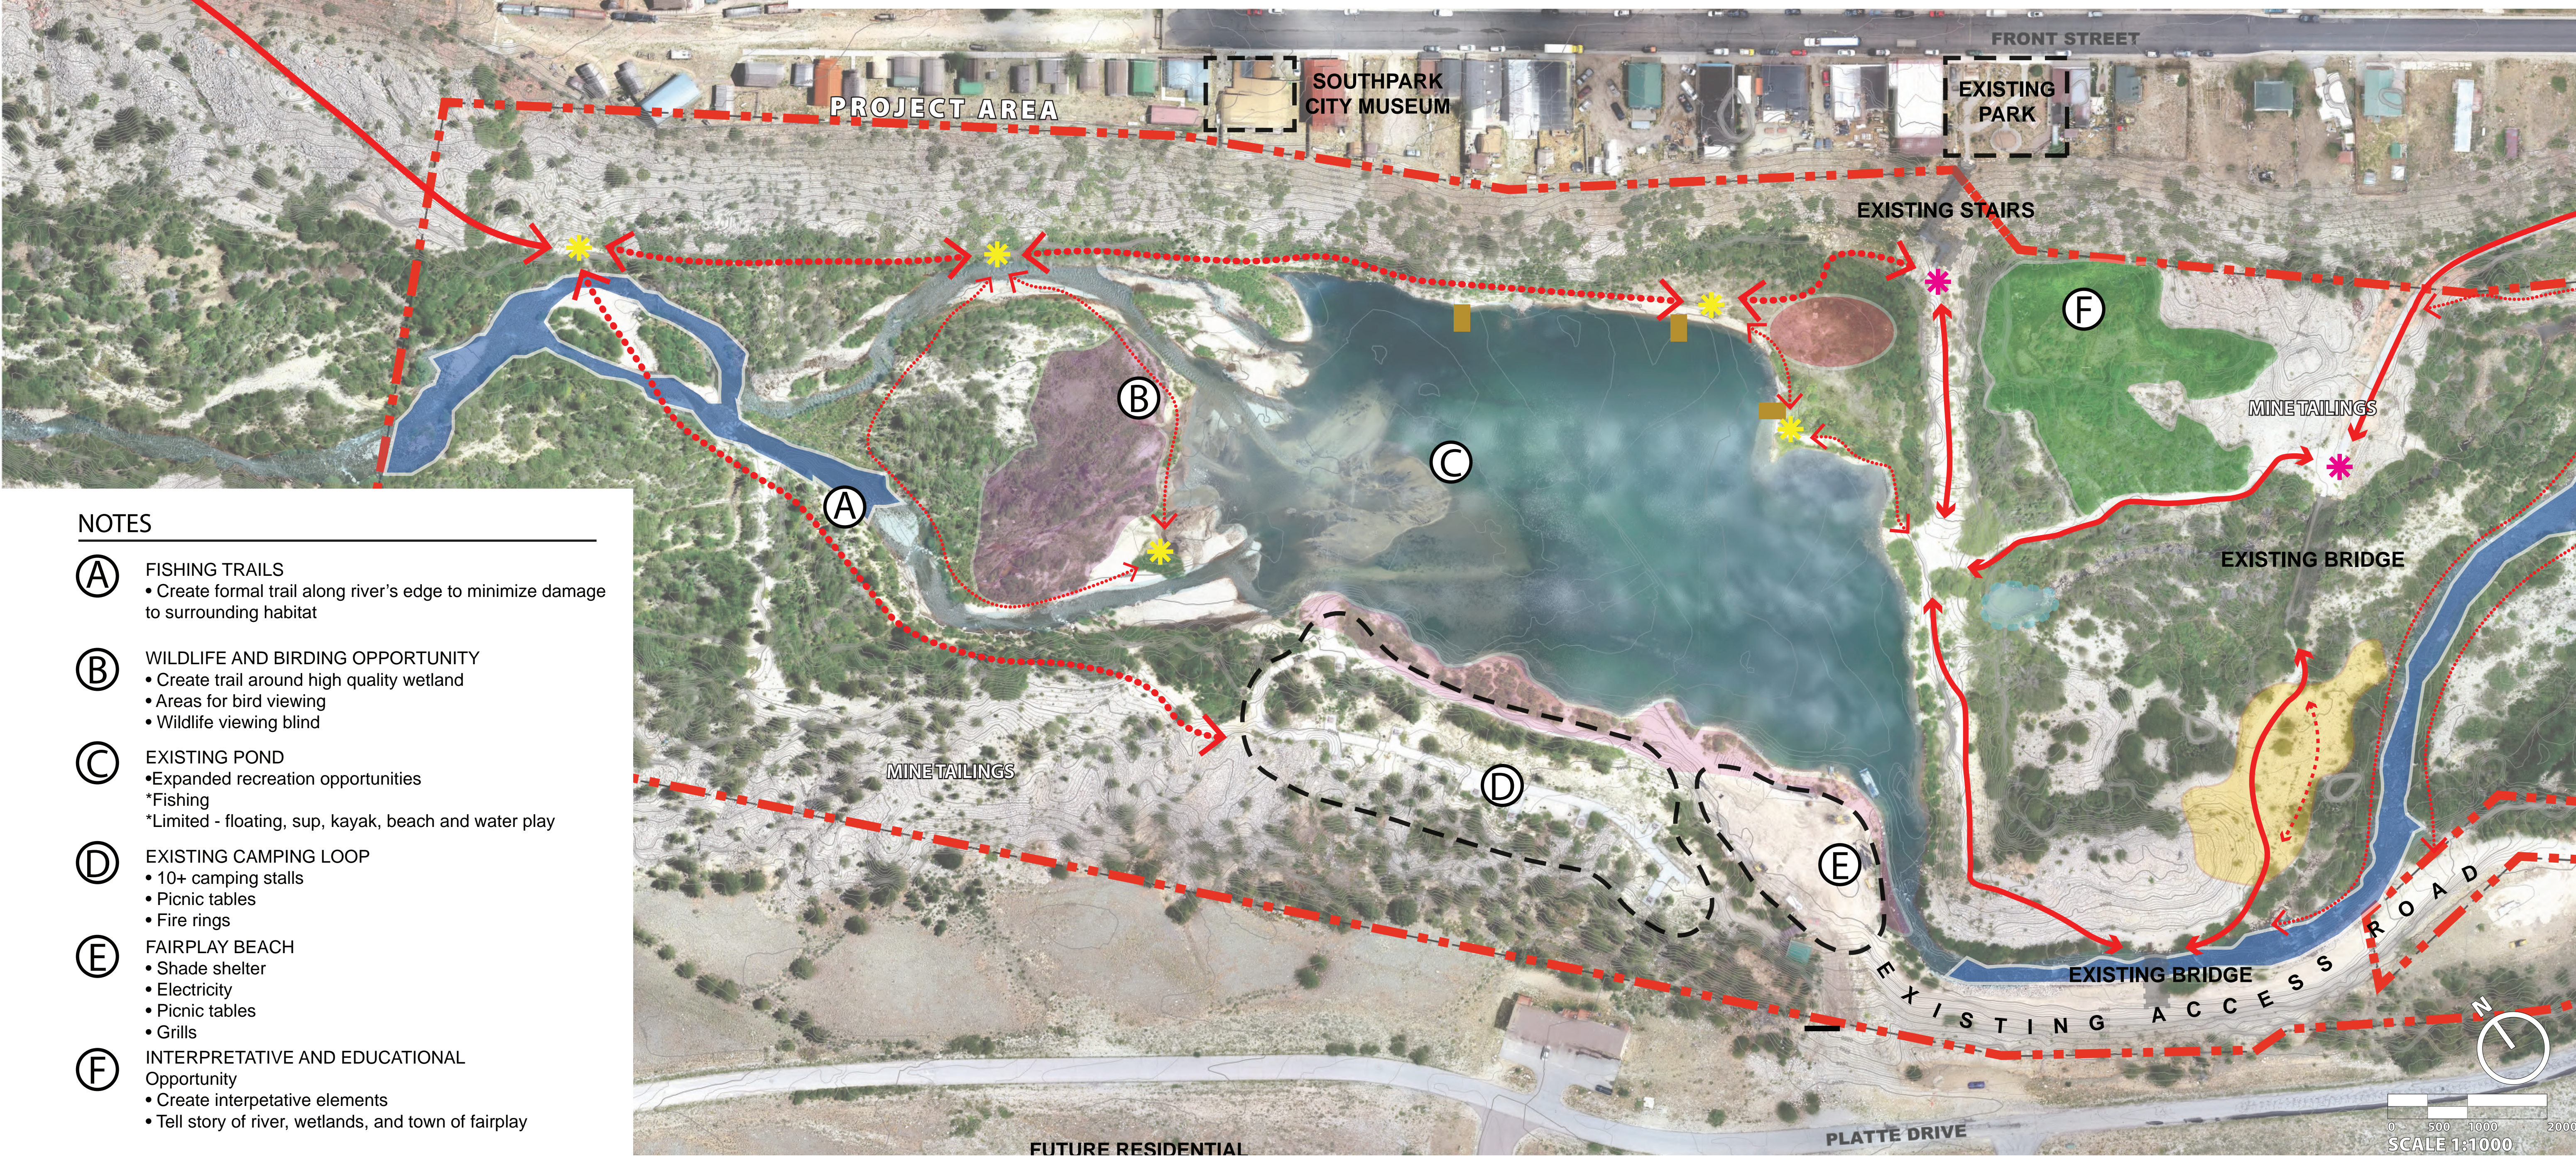
- (A)** FISHING TRAILS
 - Create formal trail along river's edge to minimize damage to surrounding habitat
- (B)** WILDLIFE AND BIRDING OPPORTUNITY
 - Create trail around high quality wetland
 - Areas for bird viewing
 - Wildlife viewing blind
- (C)** EXISTING POND
 - Expanded recreation opportunities
 - *Fishing
 - *Limited - floating, sup, kayak, beach and water play
- (D)** EXISTING CAMPING LOOP
 - 10+ camping stalls
 - Picnic tables
 - Fire rings
- (E)** FAIRPLAY BEACH
 - Shade shelter
 - Electricity
 - Picnic tables
 - Grills
- (F)** INTERPRETATIVE AND EDUCATIONAL Opportunity
 - Create interpetative elements
 - Tell story of river, wetlands, and town of fairplay

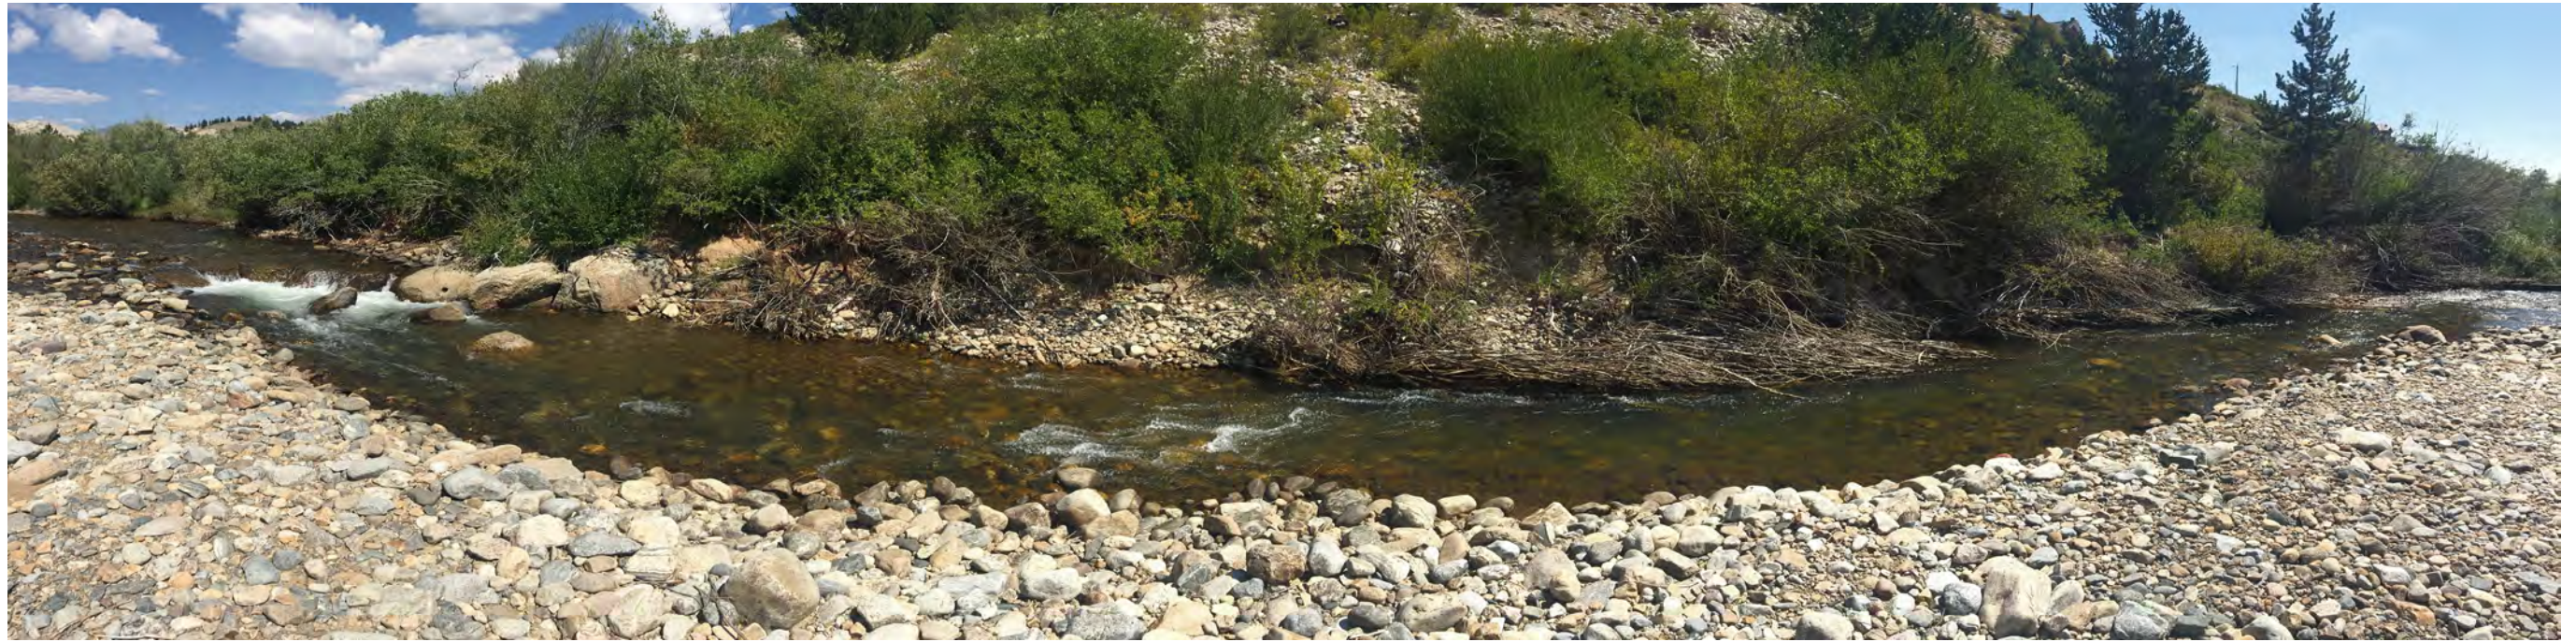
View looking at area where significant bank erosion is taking place. Active erosion taking place at both low and high flows. Significant at high flows. Recommended intervention would be to stabilize bank with root wads and boulders.

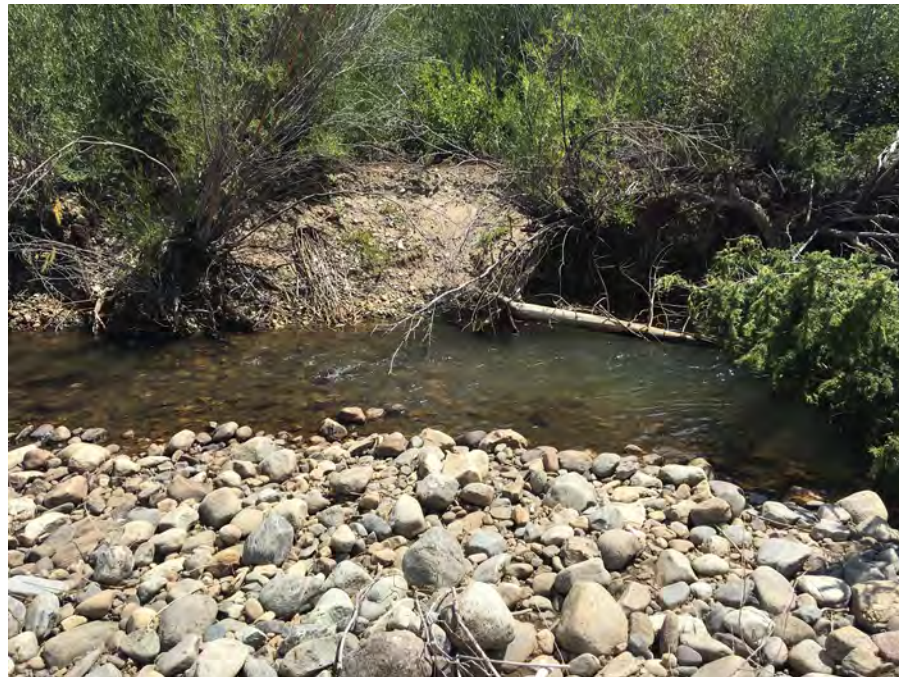
View of active bank erosion area. Recommended intervention would be to stabilize bank with root wads and boulders.

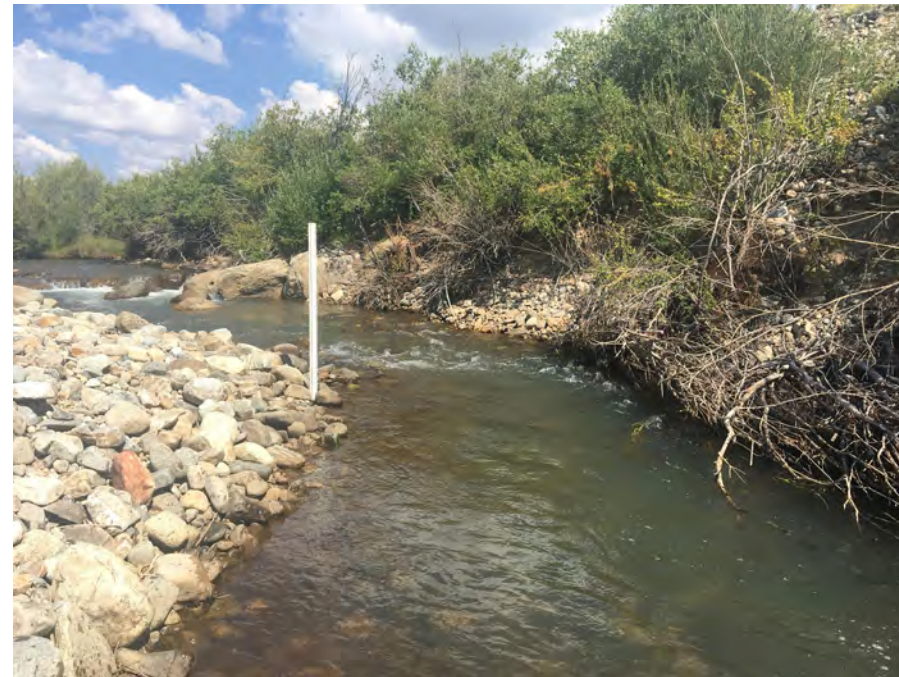
View of bank erosion area influenced by cobble deposition causing incising of stream channel and increased flow.

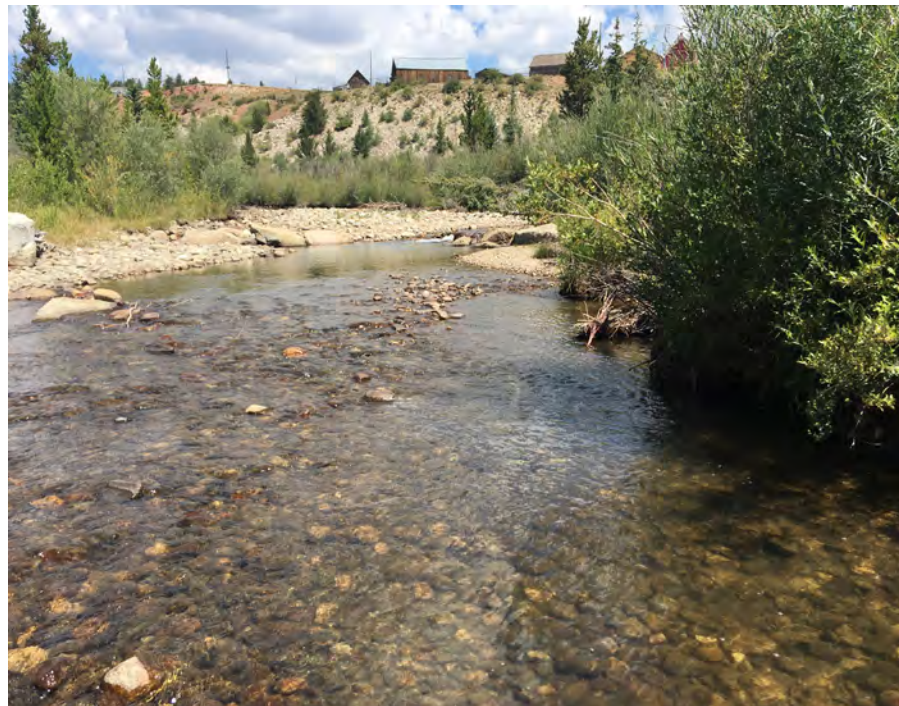
View looking at low functioning stream section. Recommend intervention grade point bars and low flow channel to increase habitat.

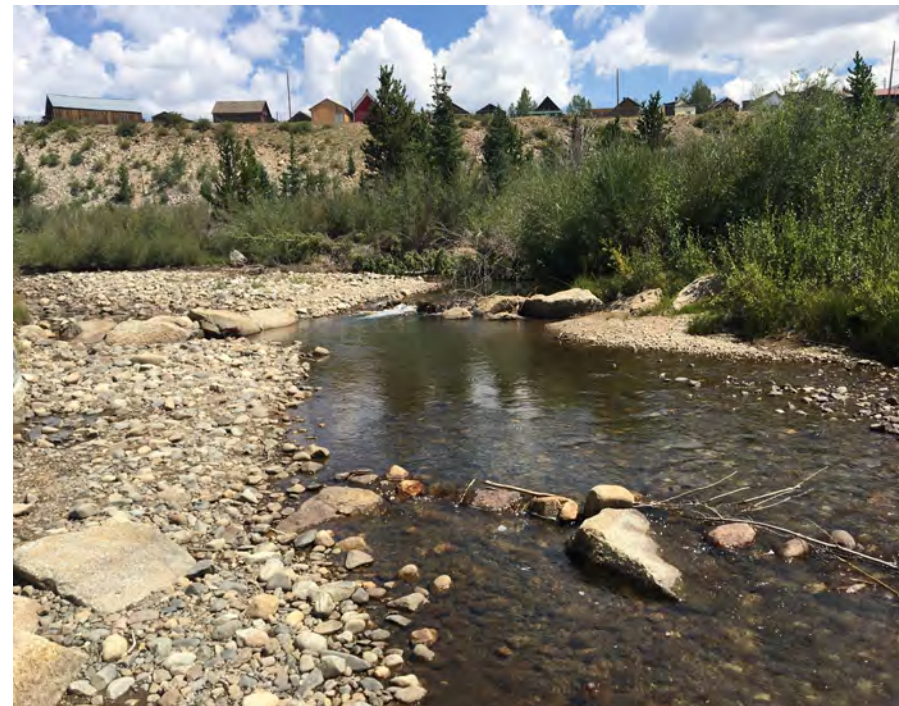
View looking at low function stream system. Regrade low flow channel to improve holding water for fish.

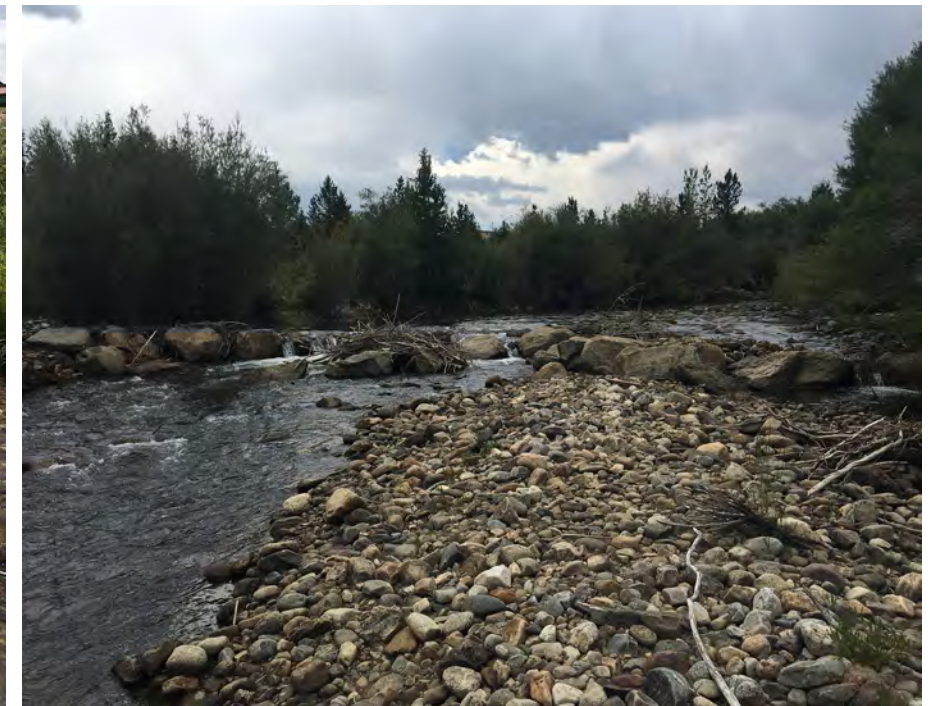
View looking at existing structure requiring maintenance. Regrade cobble bar to allow for pool function.

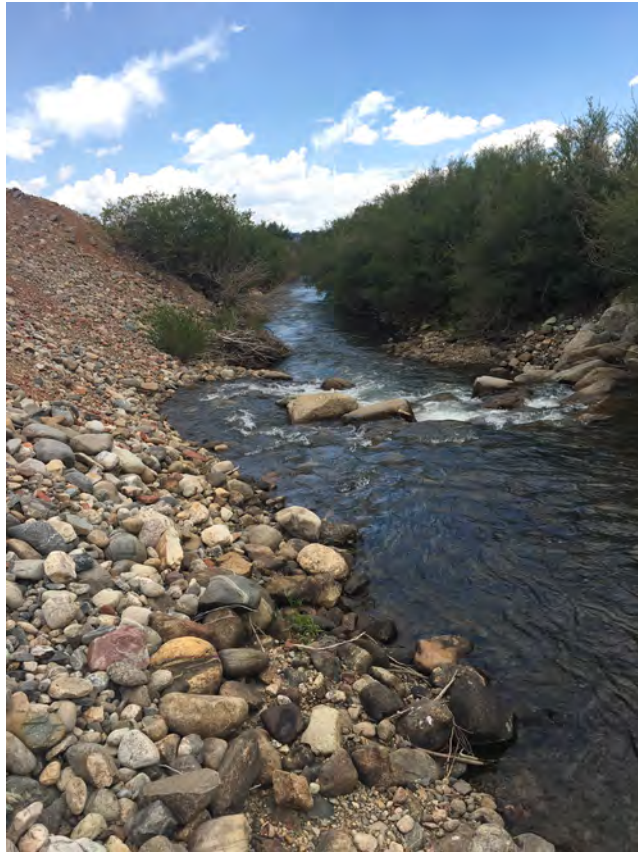
View looking downstream at bank erosion leading to undermining of existing river structure. Recommended intervention would be to remove or regrade tailings to stabilize slope. Key in additional boulders to stabilize structure. Add riparian plantings to stabilize slope.

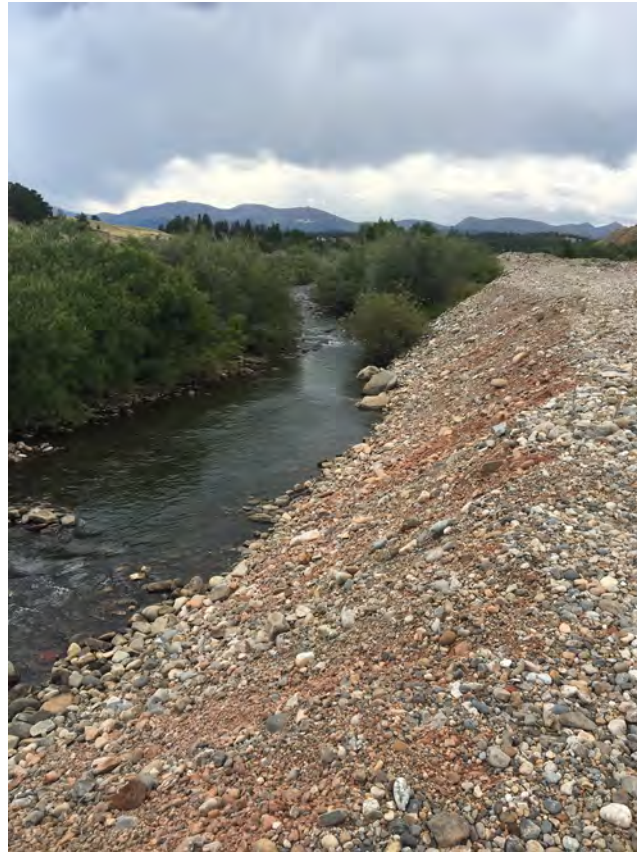
View looking upstream at significantly impaired section of river bank. Highly incised bank is actively eroding. Recommended intervention would be to remove and regrade tailings to stabilize slope. Add riparian plantings to stabilize slope.

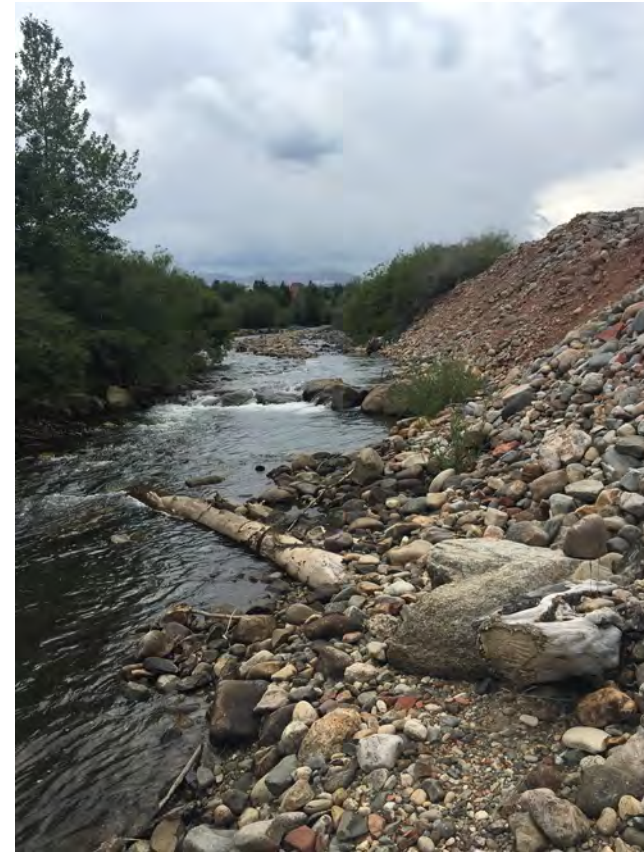
View looking upstream at significantly impaired section of river. Highly incised bank.

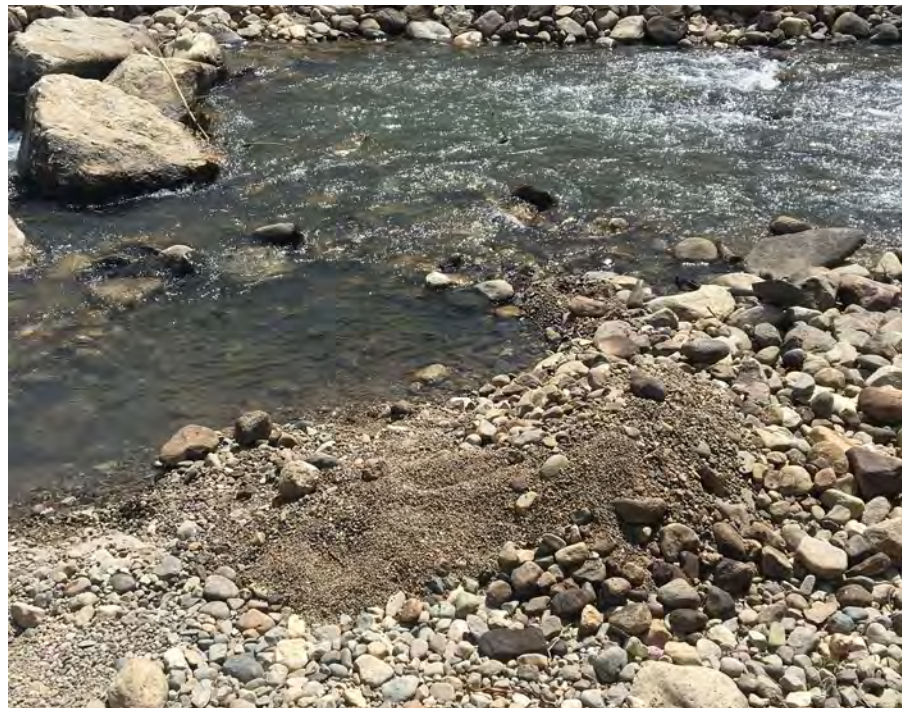
View looking at erosion and undermining taking place to existing river structure from gold panning activities.

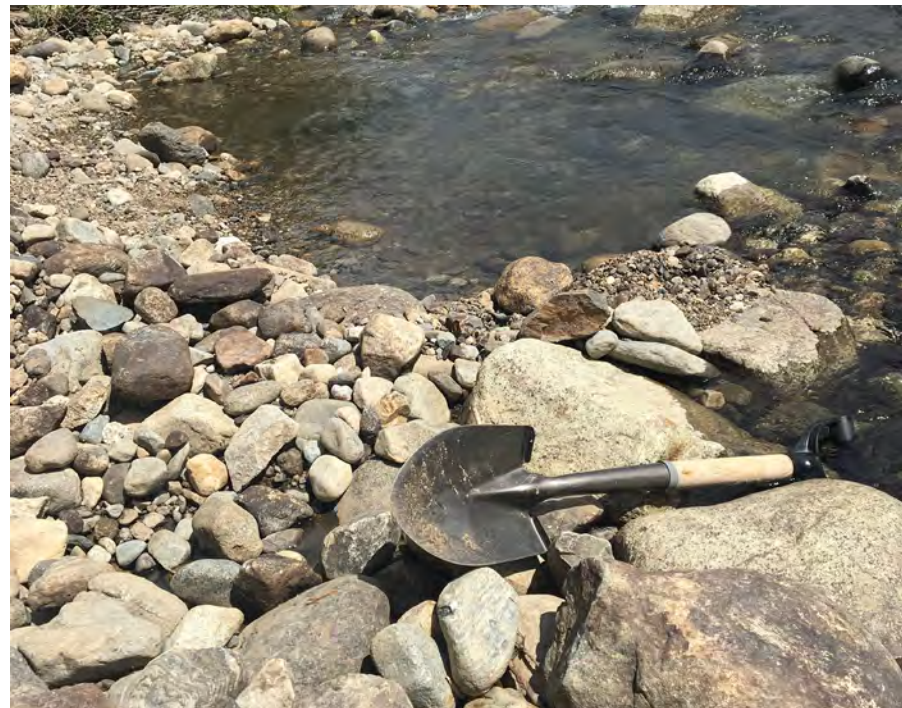
View looking at pool and bank degradation caused from gold panning activities.
